General Document 37

AIRCRAFT ACCIDENT INVESTIGATION AT ARL
THE FIRST 50 YEARS

by
J.L. KEPERT

MARCH 1993
93-16620

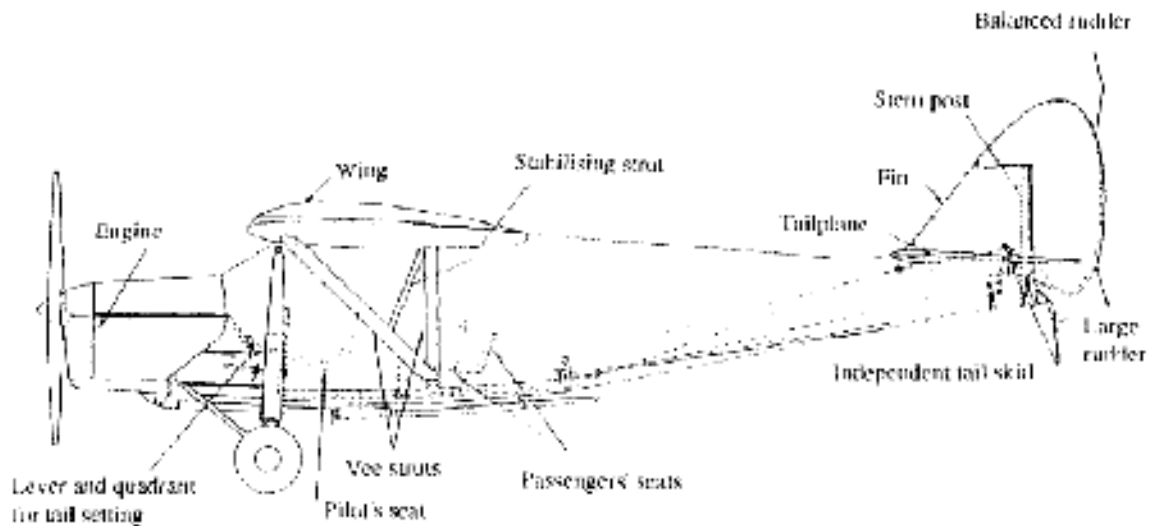
it easily met the load factor requirements of +5.5g and -2.75g specified for the normal category when the type certificate was issued in May 1930. Additional tests carried out by the RAE Farnborough supported this conclusion but indicated the desirability of fitting a stabilising bar to the forward leg of the vee strut; see Fig. 1. This mod was incorporated on 21 March 1932.

Fig. 1 D.H. Puss Moth showing location of stabilising strut
