## CRITICAL SERVICE BULLETIN

**SB-185A**

SUBJECT: **WING ATTACH SHOULDER BOLTS**

AA-5	AA5-0001 and subsequent
AA-5A	AA5A-0001 and subsequent
AA-5B	AA5B-0001 and subsequent
AG-5B	99998, 10000 thru 10174

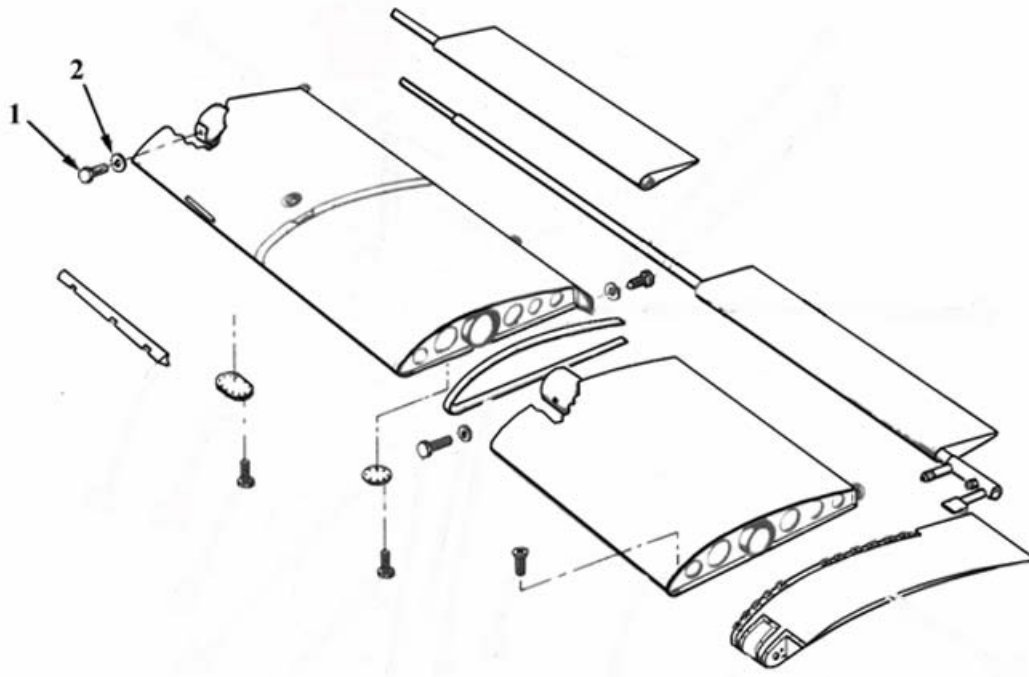
**FIGURE 2**

We have received reports of inboard wing attach shoulder bolt (P/N 901044-2 and -3) failures on some of the above mentioned aircraft which may compromise the structural integrity of the aircraft and could result in loss of flight control should the second bolt in either wing fail. These failures were detected during routine scheduled 100 hour inspection while retorquing the wing attach shoulder bolts and had failed prior to reaching the bolt service life limit of 7,250 hours. No abnormal flight characteristics have been experienced prior to discovery of the broken shoulder bolts.

It is suspected that wing attach shoulder bolt failures occurred because of excessive wing to center spar clearance caused by the failure to check and to shim to the correct tolerance, per the Tiger Aircraft/Gulfstream Aerospace AA-5 Series Maintenance Manual Chapter 57 (or Tiger Aircraft AG-5B Maintenance Manual Chapter 57), during wing installation.

1. Prepare the aircraft for safe maintenance.
  - a. Disconnect the battery.
  - b. Connect the airframe to a suitable ground.
2. Remove the access panel from the lower wing root fairing (Figure 1).
3. From within the wing root, remove the (2) wing attach shoulder bolts (Figure 2) at each wing root main spar.
4. Inspect each of the four P/N 901044-3 wing attach shoulder bolts as follows:

6. Reinstall the shoulder bolts as follows:
- a. Through the access panel under the wing root fairing, install the shoulder bolt and washer and tighten until the head of the bolt contacts the spar.

- b. Rotate the bolt counter clockwise two full turns then using a torque wrench, determine the friction drag on the bolt.
  - c. Add the friction drag to 85 inch pounds to establish the total torque value and torque the shoulder bolt.

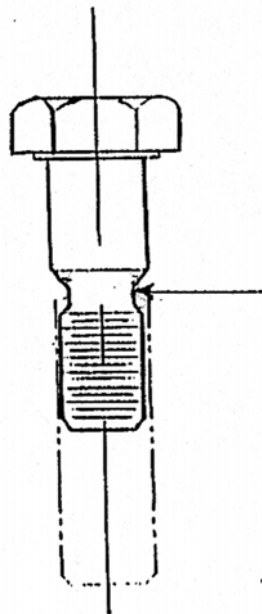
**FIGURE 3**

- b. Inspect the Shoulder Bolt profile. The Shoulder Bolt should have a smooth machined area between the threads and the shoulder bevel as shown in Figure 3. If the threads contact the shoulder of the bolt, the bolt must be removed from service and replaced with a bolt of the correct profile.
